Automobile Status Report

2021 Nissan ROGUE SPORT

Multi-Point Inspection Checklist

Additional Service Recommendations

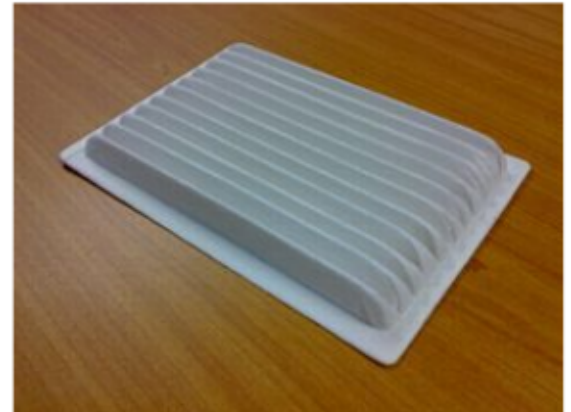
Cabin Air Filter Replacement

If not replaced, the air conditioning system will develop an odd odor. The air conditioning filter, also known as the cabin filter, removes dust and pollen from entering the car cabin.

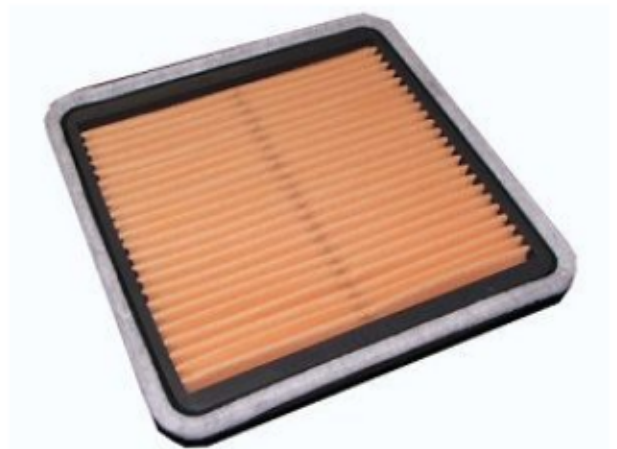
Engine Air Filter Replacement

If not replaced, poor gas mileage and premature engine wear will result.

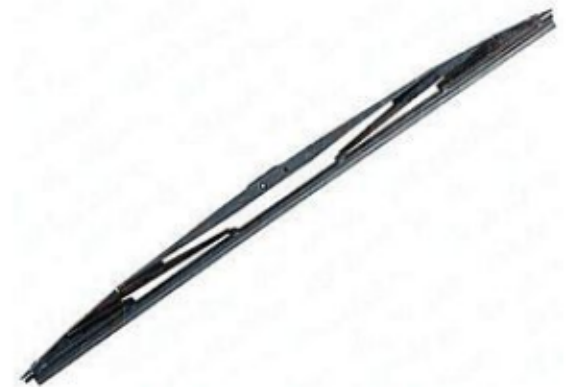
Windshield Wiper Blade

Wiper Blade Replacement - Front

If not replaced, worn out wiper blades can cause restricted visibility and permanent damage to the windshield.
