Automobile Status Report

2019 Chevrolet MALIBU

Multi-Point Inspection Checklist

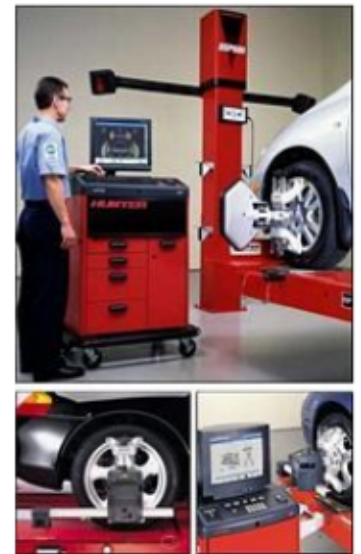
Alignment

applies to both front and rear wheel drive vehicles. Aligning a car or truck involves the adjustment of the vehicle's suspension, not the tires and wheels. The direction and the angles that the tires point in after the alignment is complete, however, are critically important. There are four factors involved in setting the alignment to specification: caster, camber, toe and ride height.

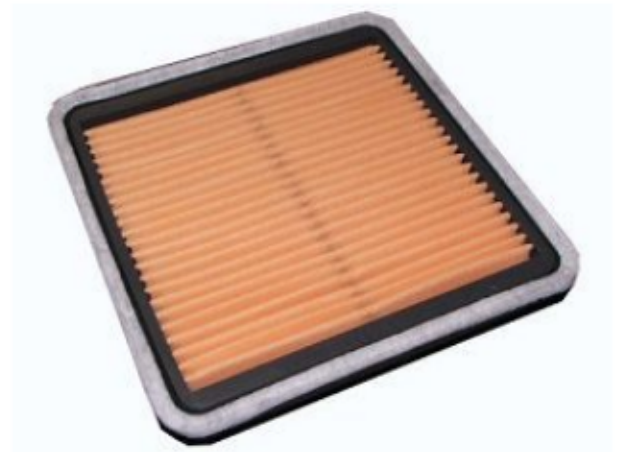
Air Filter

Cabin Filter & In-Cabin Micro Filter: due by time and mileage, every 15k miles
