Capital City Nissan Of Topeka

Automobile Status Report

2017 Dodge GRAND CARAVAN

VIN 2C4RDGBG9HR678214

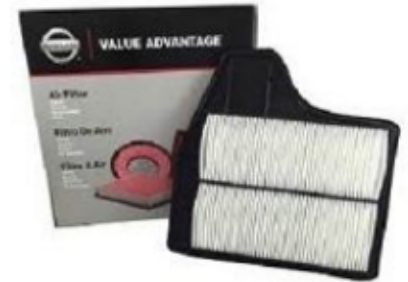
Cabin Filter & In-Cabin Micro Filter: Recommended every 15,000 miles per owners manual. The cabin air filter help keep debris from entering the blower motor and HVAC system causing damage. It also filters out a lot of pollen and dirt to help with allergies. Allowing for a clean, fresh, and healthy air to come into the cabin.

The cabin filter / in-cabin microfilter function like your furnace filter at home. They clean the air by trapping pollen, bacteria, dust and exhaust gases that may find their way into a vehicle's HVAC system. Dirty filters reduce your heating and cooling efficiency

Your Cabin Filter and In-Cabin Micro Filter should be inspected at each service and replaced every other oil change or after 12 months.

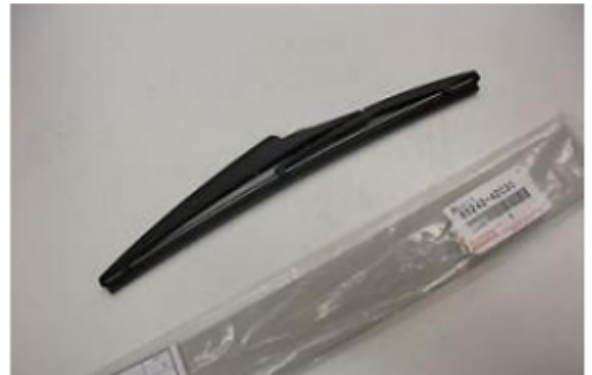
*Windshield Wiper Blade - (Rear)

The rear windshield wiper will need to be replaced occasionally. When you notice the wiper streaking on the glass or becoming worn, remove it immediately and have it properly replaced.

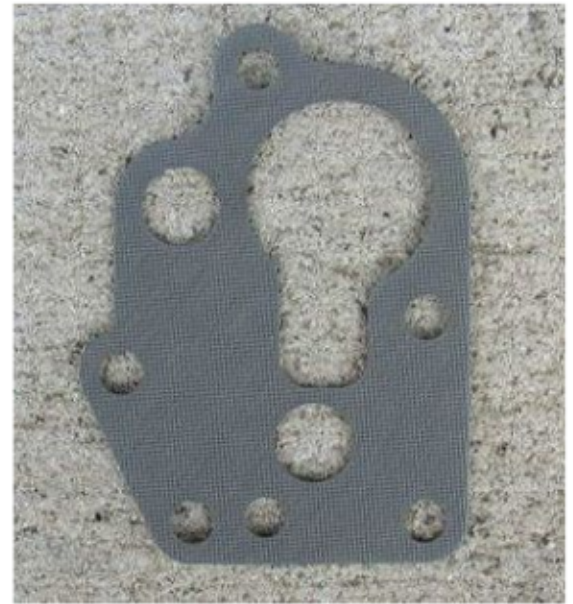
Oil Filter Housing Gasket: recommended reseal per leaking

If not replaced, a faulty oil filter housing gasket will prevent a proper seal. This can lead to oil leaking from the oil filter housing.

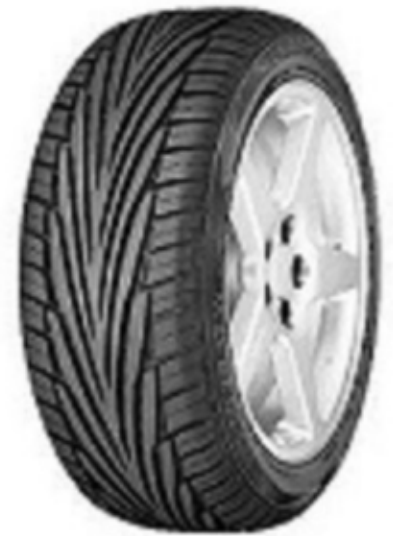
Tires - 2: 2256517 nexen rear tires measuring at 4/32. recommended rotate new tires to front

According to most states' laws, tires are legally worn out when they have worn down to 2/32" of remaining tread depth. As a tire wears it's important to realize that the tire's ability to perform in rain and snow will be reduced. With 2/32" of remaining tread depth, resistance to hydroplaning in the rain at highway speeds has been significantly reduced, and traction in snow has been virtually eliminated. If rain and wet roads are a concern, you should consider replacing your tires when they reach approximately 4/32" of remaining tread depth.
