## Automobile Status Report

2016 Nissan ALTIMA

**VIN** 1N4AL3AP8GC154575

# Multi-Point Inspection Checklist

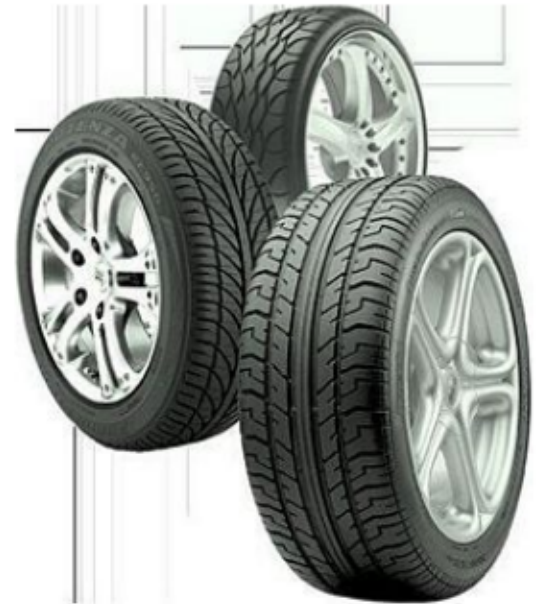
Tires

## **Tires - 4: 2155517. front tires at 3/32. rear tires are at 4/32 on right side and 8/32 on left side**

According to most states' laws, tires are legally worn out when they have worn down to 2/32" of remaining tread depth. As a tire wears it's important to realize that the tire's ability to perform in rain and snow will be reduced. With 2/32" of remaining tread depth, resistance to hydroplaning in the rain at highway speeds has been significantly reduced, and traction in snow has been virtually eliminated. If rain and wet roads are a concern, you should consider replacing your tires when they reach approximately 4/32" of remaining tread depth.

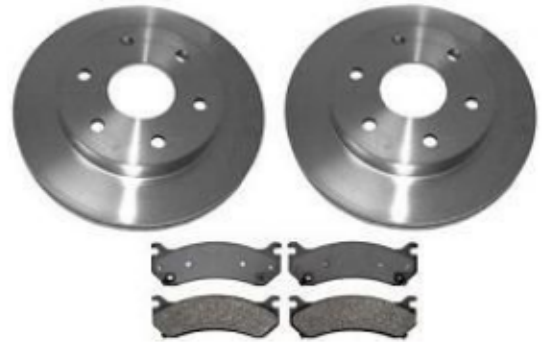
## **Brake Job - Replace Rear Brake Pads and Resurface Rotors: recommended rear brakes as they are measuring at 2mm**

Brake pads must be replaced before the friction material is worn away completely. If it isn't, metal-to-metal contact will occur between the brake rotor and the worn-out brake pad. If metal-to-metal contact occurs, the brake rotor will be damaged, and it will need to be resurfaced or replaced. When the pads are replaced, the rotor must be resurfaced smooth to allow the new pads to have an even contact surface to work with. Only a small amount of material can be machined off of a rotor before it becomes unusable and must be replaced.

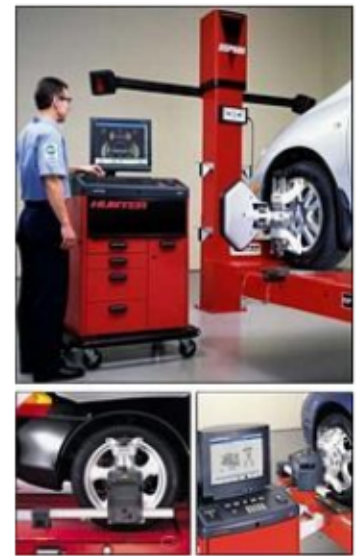
Alignment

## **Alignment: when tires are installed to ensure no abnormal wear occurs**

If not done, you will see uneven or rapid tire wear, pulling or drifting away from a straight line, and wandering on a straight level road. It can also cause extra load on certain suspension components, making them more likely to fail.

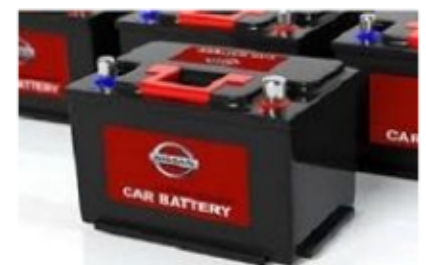
**"Nissan" - Batteries: recommended per testing low and have to jumpstart every time to drive it. also when new battery is installed retest charging system**

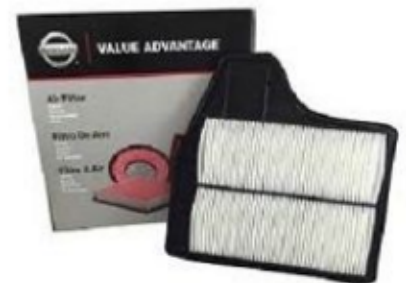
## Cabin Filter & In-Cabin Micro Filter: recommended every 15,000 for that clean and fresh air can flow through the hvac system

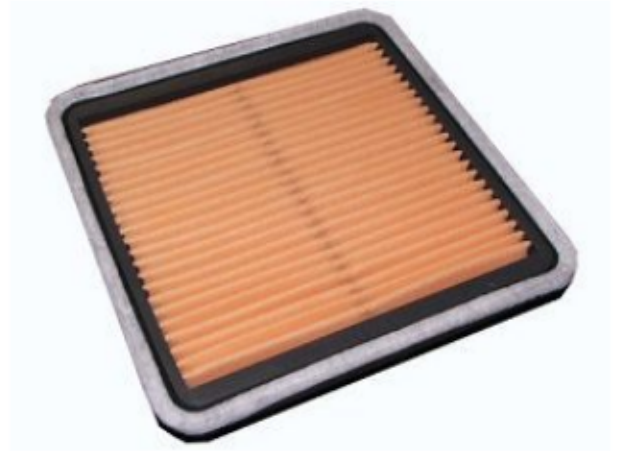
## Engine Air Filter Replacement

If not replaced, poor gas mileage and premature engine wear will result.

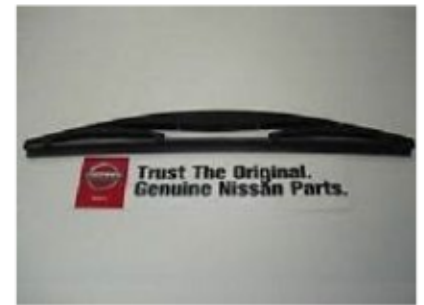
## Front Wipers
