Automobile Status Report

2023 Nissan ROGUE

VIN 5N1BT3BB2PC781334

Multi-Point Inspection Checklist

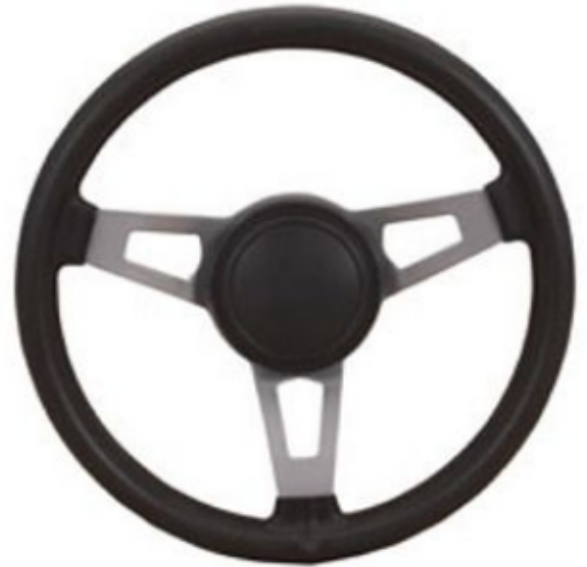
Steering Wheel: THE VOLUME CONTROL ON THE STEERING WHEEL IS LOOSE AND NOT OPERATING PROPERLY. RECOMMEND REPLACEMENT OF THE STEERING WHEEL.

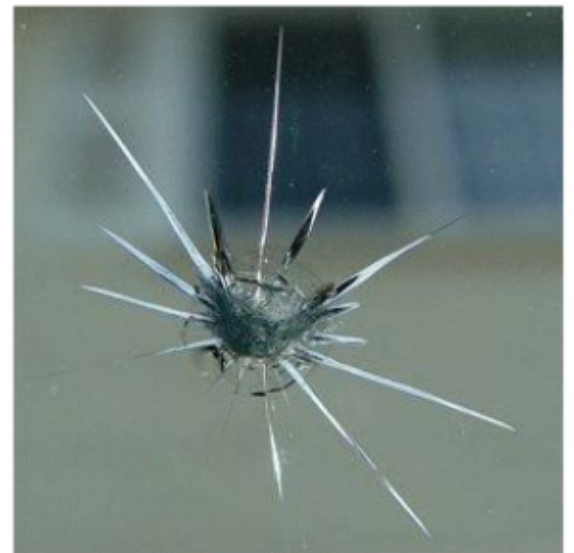
Windshield Chip Repair: THERE IS A CHIP IN THE WINDSHIELD.

Every rock chip will eventually crack out, and it is hard to determine how long any chip can hold until the damage is too large to repair, but if that little chip spreads, it will cost you a new windshield.

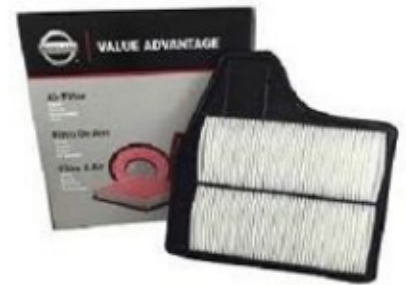
Cabin Filter & In-Cabin Micro Filter

Your Cabin Filter and In-Cabin Micro Filter should be inspected at each service and replaced every other oil change or after 12 months.

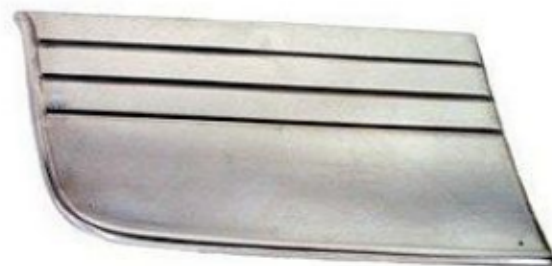
Gravel Shield: THE LOWER ENGINE SHIELD IS MISSING.

If not repaired, the vehicle's exterior becomes vulnerable to debris that can be projected when driving at higher speeds.

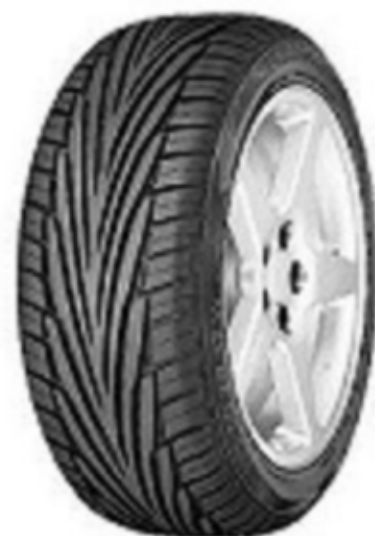
Tires - 1: WHILE PERFORMING REPAIRS ON THE VEHICLE A NAIL WAS NOTICED IN THE SIDE WALL OF THE LEFT REAR TIRE. RECOMMEND REPLACEMENT OF 1 TIRE. 2356018 KELLY EDGE TOURING A/S
